DEPARTMENT OF TRANSPORTATION

Contract #: 04-0120F4Cty: SF/ALA Rte: 80 PM: 13.2/13.9File #: 69.28**WELDING INSPECTION REPORT****Resident Engineer:**Pursell, Gary**Address:** 333 Burma Road**City:** Oakland, CA 94607**Report No:** WIR-001615**Date Inspected:** 13-Feb-2008**Project Name:** SAS Superstructure**OSM Arrival Time:** 900**Prime Contractor:** American Bridge/Fluor Enterprises, a JV**OSM Departure Time:** 1400**Contractor:** Zhenhua Port Machinery Company, Ltd (ZPMC), Changxing Island **Location:** Shanghai, China

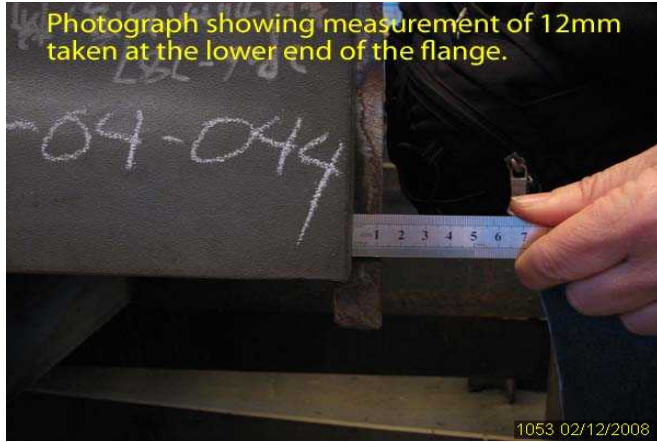
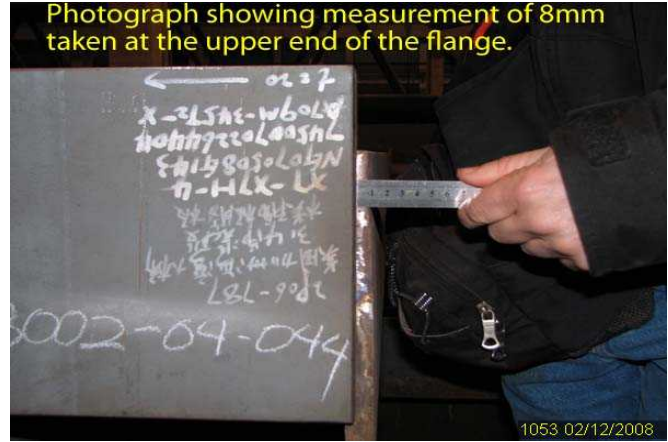
Bay 7- QA Inspector observed Floor Beam Sub Assembly FB002-04 at Flange Plate piece mark X7G and piece mark X7L did not align appear to align perpendicular to the Floor Beam. QA Observed that the drawings allow this dimension to be 10mm and did not list any tolerances. Actual measurements observed by the QA Inspector are as the following: 8mm at the upper end of flange and 12mm at the lower end of flange. QA Inspector discussed this condition with QA Task Leader Mr. Dave McClary and Caltrans Structures Material Representative (SMR) Mr. Ady Velasco. After further review of the condition and research, Mr. Velasco informed the QA Inspector that per the approved Dimensional Control-Tolerance RI-GB-R04, this condition is within the allowed tolerance of 2mm.
